TESTIMONY

Psyttalia, Athens, Greece – Sewage plant

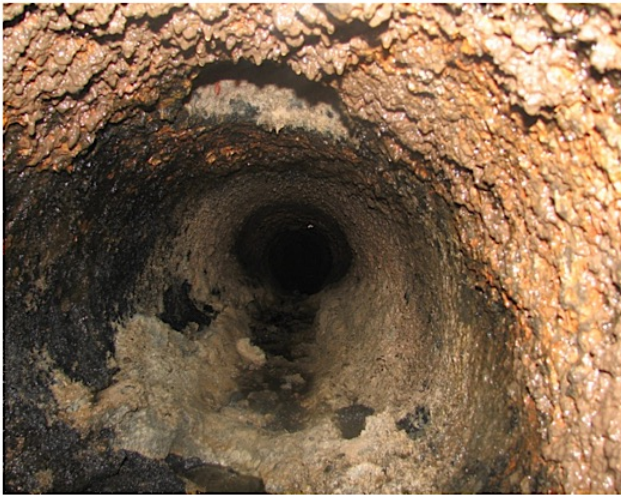
- Left photo: Struvite blocking the 30cm diameter pipe. Mechanical Cleaning every 3-4 months before Magnetizer®
- Right photo: Same pipe after 6 months with Magnetizer® that discolored the existing struvite. Plant operating for 12 months tube struvite free.

We hereby confirm Magnetizer Hellas Ltd, after conducting a study, installed on May 2008 MAGNETIZER single focus magnetic systems in order to solve problems caused by the struvite and other types of scale at the sludge dewatering unit of the sewage treatment plant of Psytallia.

Magnetizer systems were installed at the sludge feed lines of the centrifuges and at the leachate output lines.

Before installation of Magnetizer units, the struvite scale deposits were so intense resulting in the need for mechanical cleaning of the centrifuges as well as the leachate output lines approximately every 6 months.
